## **Paper 31**

### **PIPE FEATURES IDENTIFIED DURING INLINE INSPECTION USING MFL PIGS**

Susanne Höhler\*, Hossein Karbasian  
Salzgitter Mannesmann Forschung GmbH, Duisburg, Germany

Johannes Brückner  
Open Grid Europe GmbH, Essen, Germany

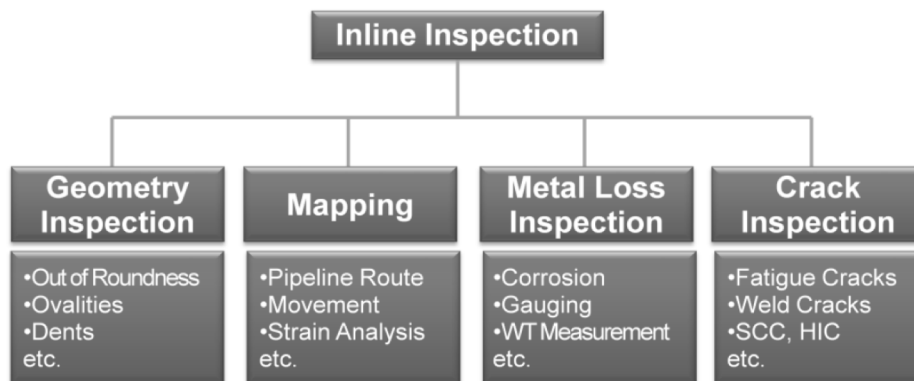
Figure 6: Inline inspection grouped by targeted analysis [3]

The major tasks of in-line inspection tools in general are the detection, localization and characterization of potential defects and flaws along a pipeline. **Figure 6** shows an overview of inspection types, which are typical for specific integrity analyses, e.g. with focus on geometric aspects, metal losses, cracks or on the mapping and evaluation of the pipeline route.
